6.0 Grand Junction, Colorado, Disposal Site

6.1 Compliance Summary

The Grand Junction, Colorado, Uranium Mill Tailings Radiation Control Act (UMTRCA) Title I Disposal Site, was inspected on March 21 and 26, 2008. The disposal cell and all associated surface water diversion and drainage structures were in good condition and functioning as designed. A portion of the disposal cell remains open and is operated by DOE to receive additional low-level radioactive waste materials from various sources. The annual inspection requirement is only applicable to the closed and completed portion of the disposal cell and the surrounding disposal site.

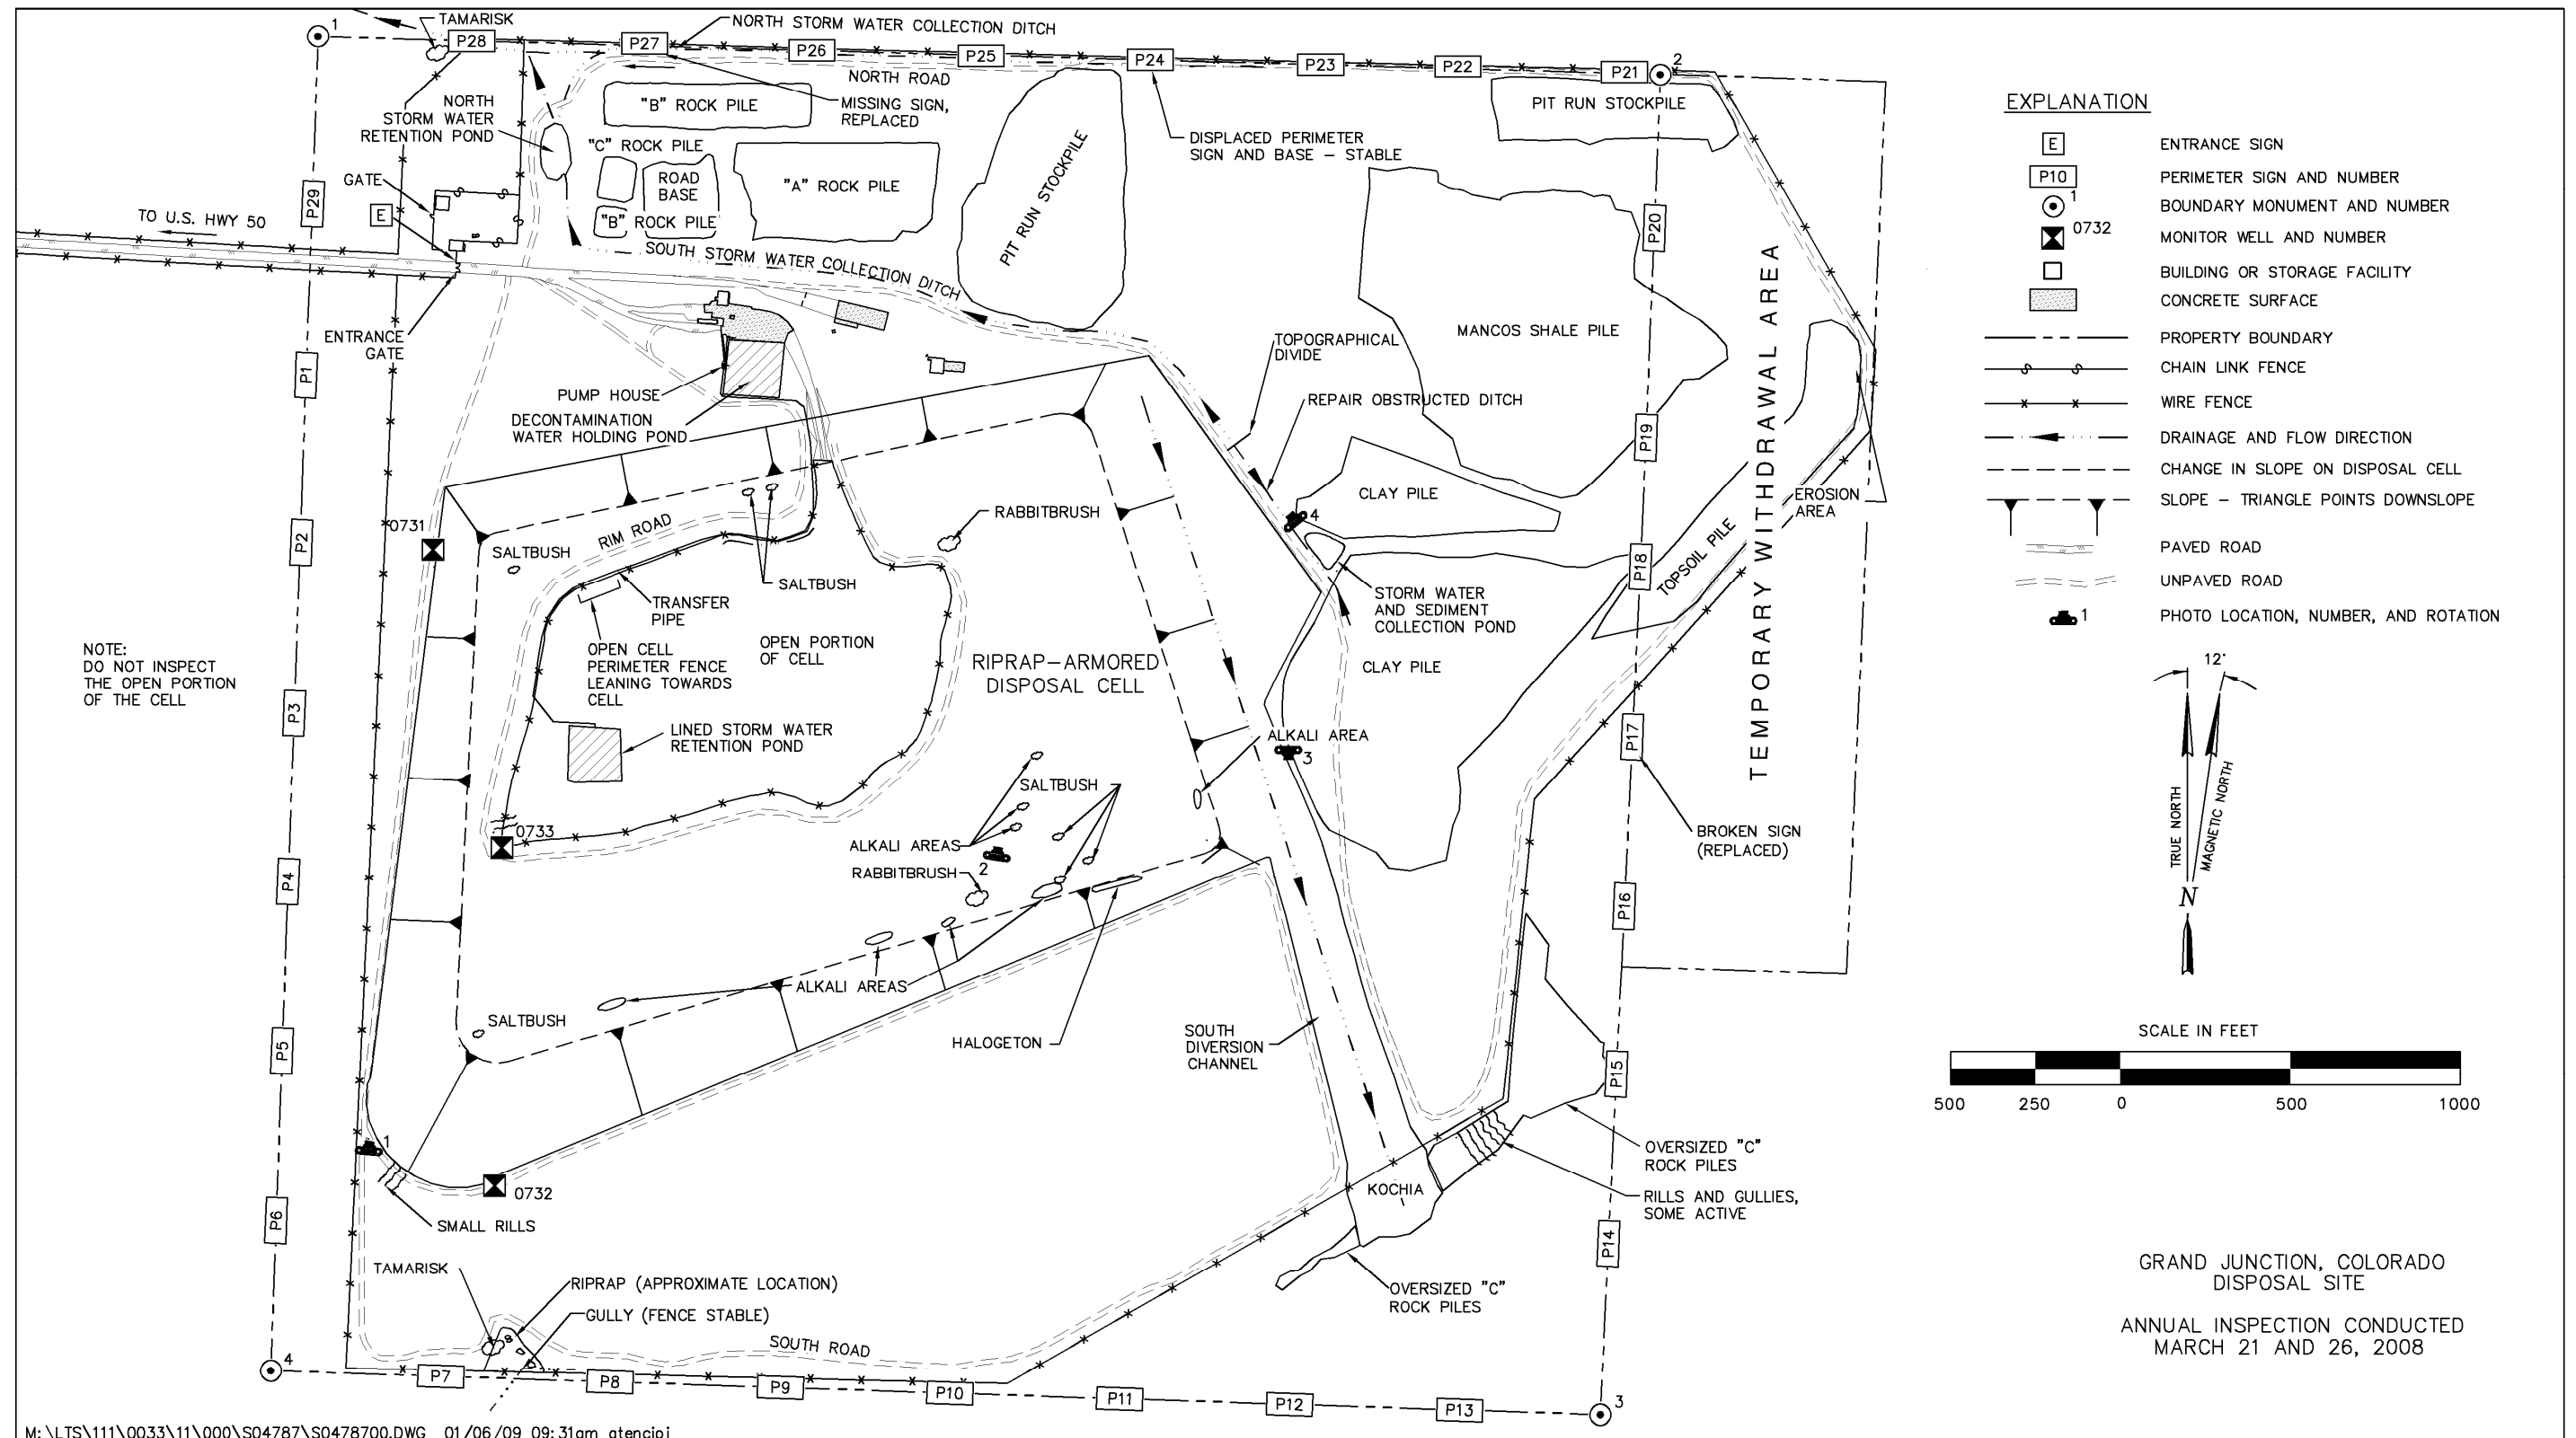
Figure 6-1. 2008 Annual Compliance Drawing for the Grand Junction Disposal Site

Entrance and Perimeter Signs—An entrance sign is located at the entrance gate, and 29 perimeter signs are located at regular intervals along the DOE property boundary. The signs are installed on galvanized steel posts set in concrete. Perimeter sign P17 was broken in half and replaced. Perimeter sign P27 was missing and replaced. Several signs are slightly bent or warped but are legible. All other signs are in excellent condition. The base of perimeter sign P24 had been slightly displaced when hit by road-grading equipment, but it is stable.
